Rain Garden located at 21st and Iris Street in Lakewood

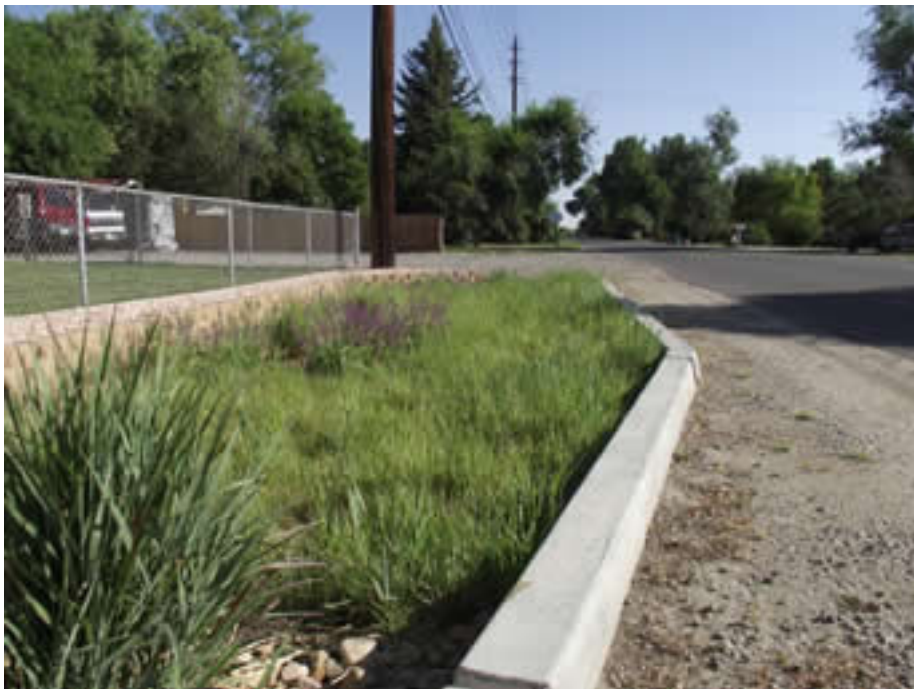
The rain garden on the north corner has a combination of drought-tolerant plantings and grasses

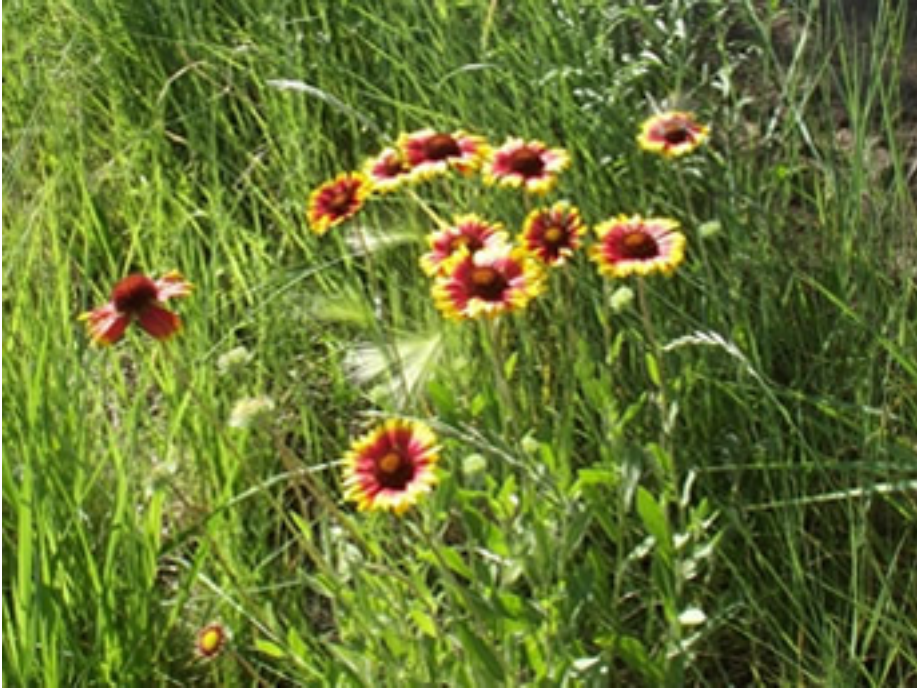
The rain garden on the south corner utilized the UDFCD grass seed mix including wild flowers. The mix is provided in Fact Sheet T-3 of Volume 3 of the USDCM.
