Denver Botanic Gardens – Mordecai Children’s Garden Green Roof

Green Roof Water Quality Summary Report

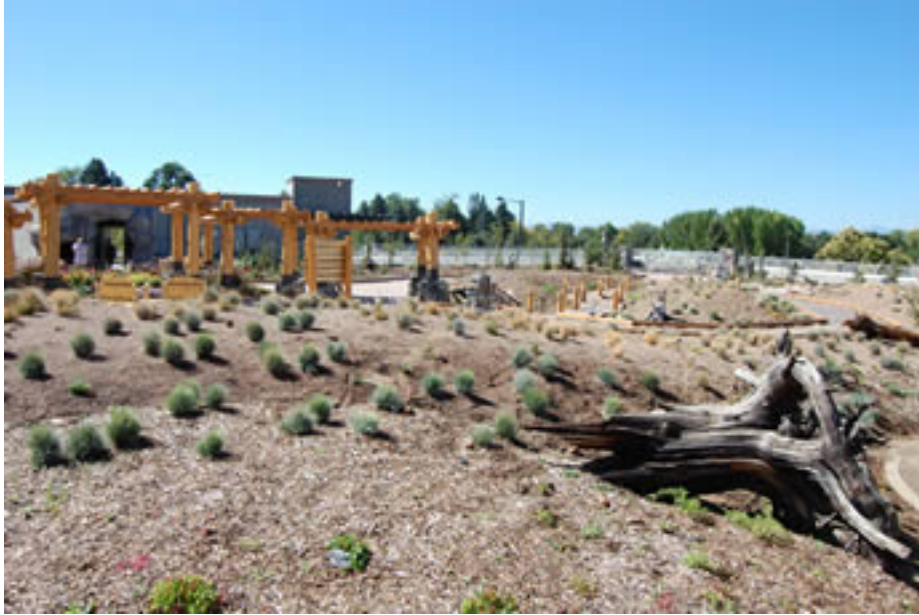
Mordecai Children's Garden Green Roof shortly following construction

This site was added to our list of BMP test sites in April 2011. Almost 0.5 acres of this 3-acre garden sits on top of a parking structure. UDFCD, working with Denver Botanic Gardens, constructed a sampling manhole designed to collect runoff from the green roof underdrain. Grade is built up on the north side of the structure and meets the portion of the garden that is a green roof. This is a very active area with wide trails, a faux mountain structure and lots of garden space with varying depths of green roof media.

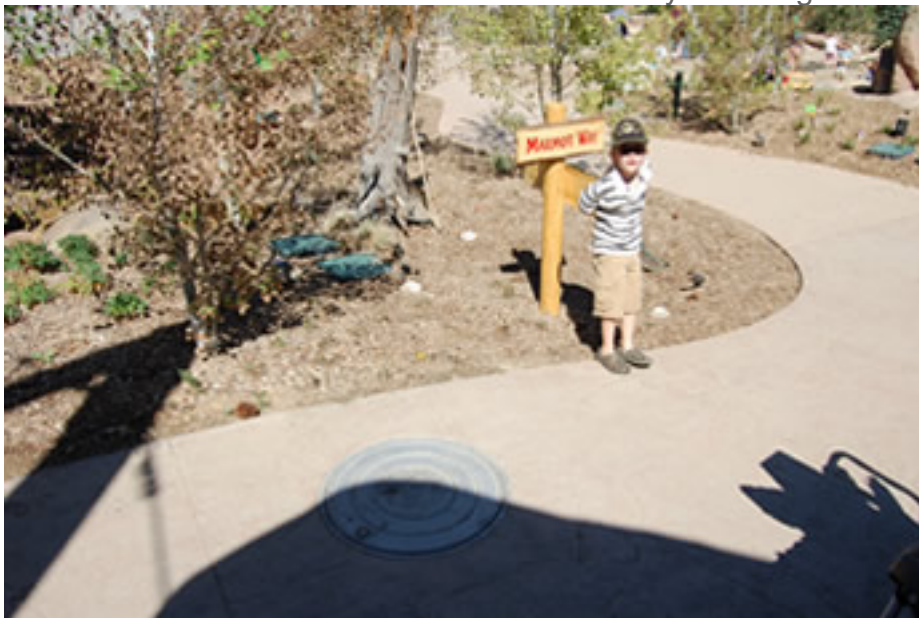
Stormsewer Sampling Manhole

Along with the sampling manhole (see photo), we also installed a rain gauge and anemometer on the west wall of the garden. When both flow is detected at the underdrain outlet and rain is detected at the rain gauge, an automated sampler starts collecting water from the underdrain and measuring flow. The anemometer allows us to correct rain gauge data to account for losses in measurement associated with wind speed.

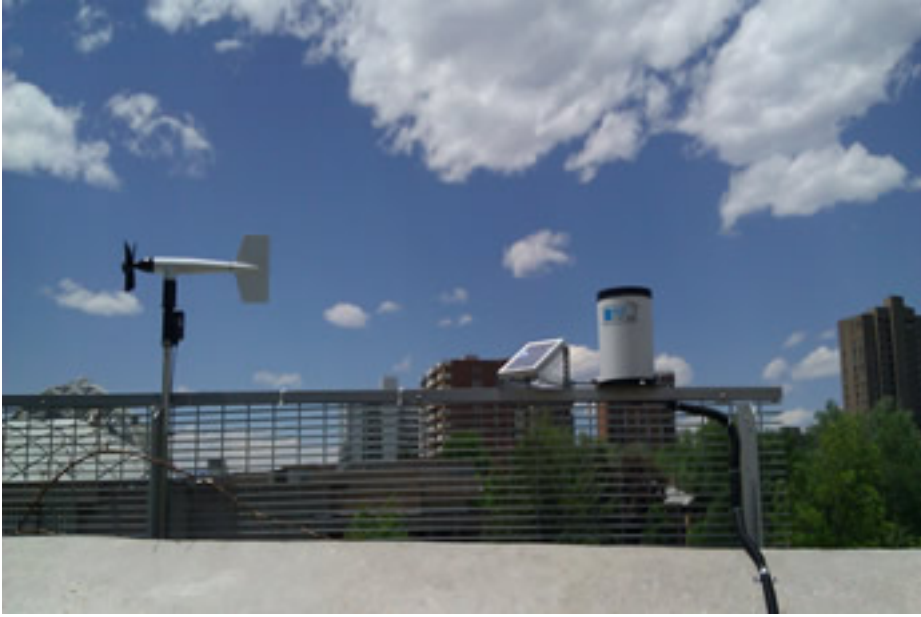
Rain gauge and anamometer
