## Grant Ranch – Extended Detention Basin in Denver

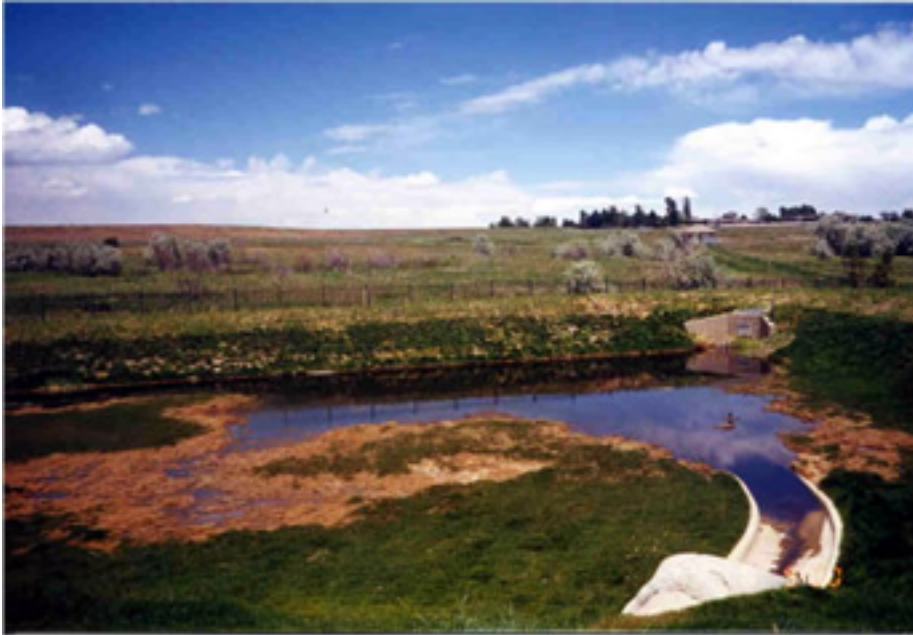
Grant Ranch EDB prior to construction of a micropool and energy dissipation.

At Grant Ranch, this Extended Detention Basin (EDB) is the first step in a treatment train approach used to treat stormwater from this residential development before entering Bow Mar Lake. UDFCD has been monitoring the inflow and effluent from this EDB since 2002. Modifications to the entrance and outlet, completed in 2004, brought the design to conformance with UDFCD criteria. Before and after photos speak to the value of including a micropool and initial surcharge volume in the design. This EDB serves as a good example for one of the most common BMPs in the Denver metropolitan area.

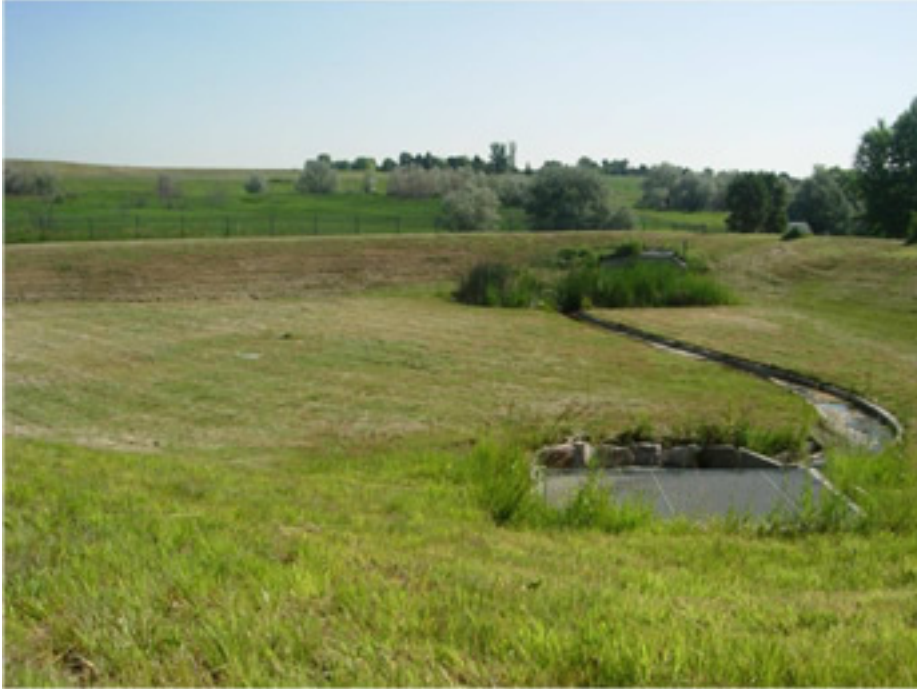
Current photo of Grant Ranch EDB

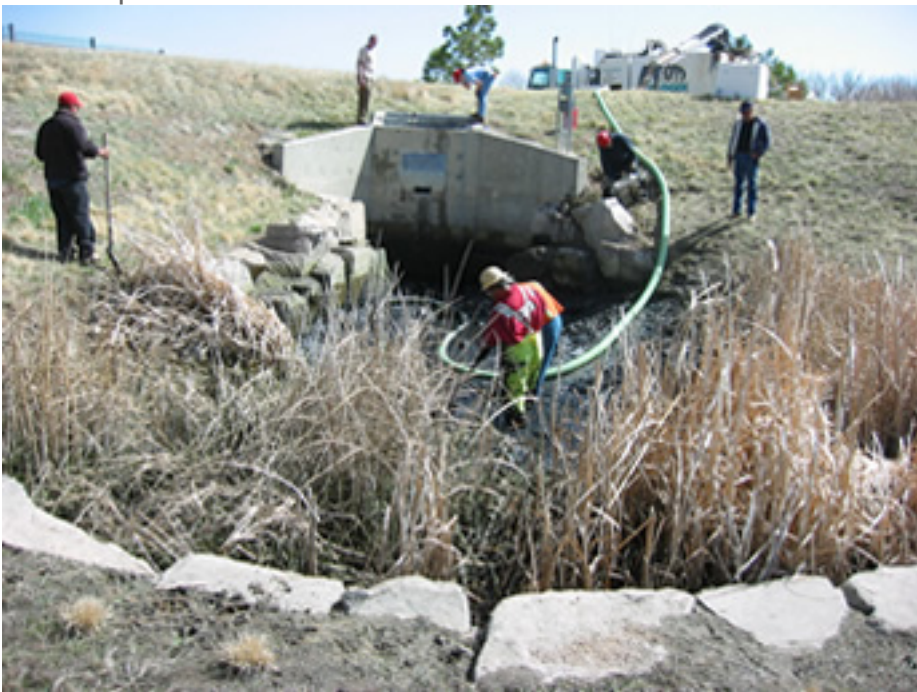
Mucking out the micropool
